| Application | HVAC |

CCS-X7-18 | ISSUED 09/2018

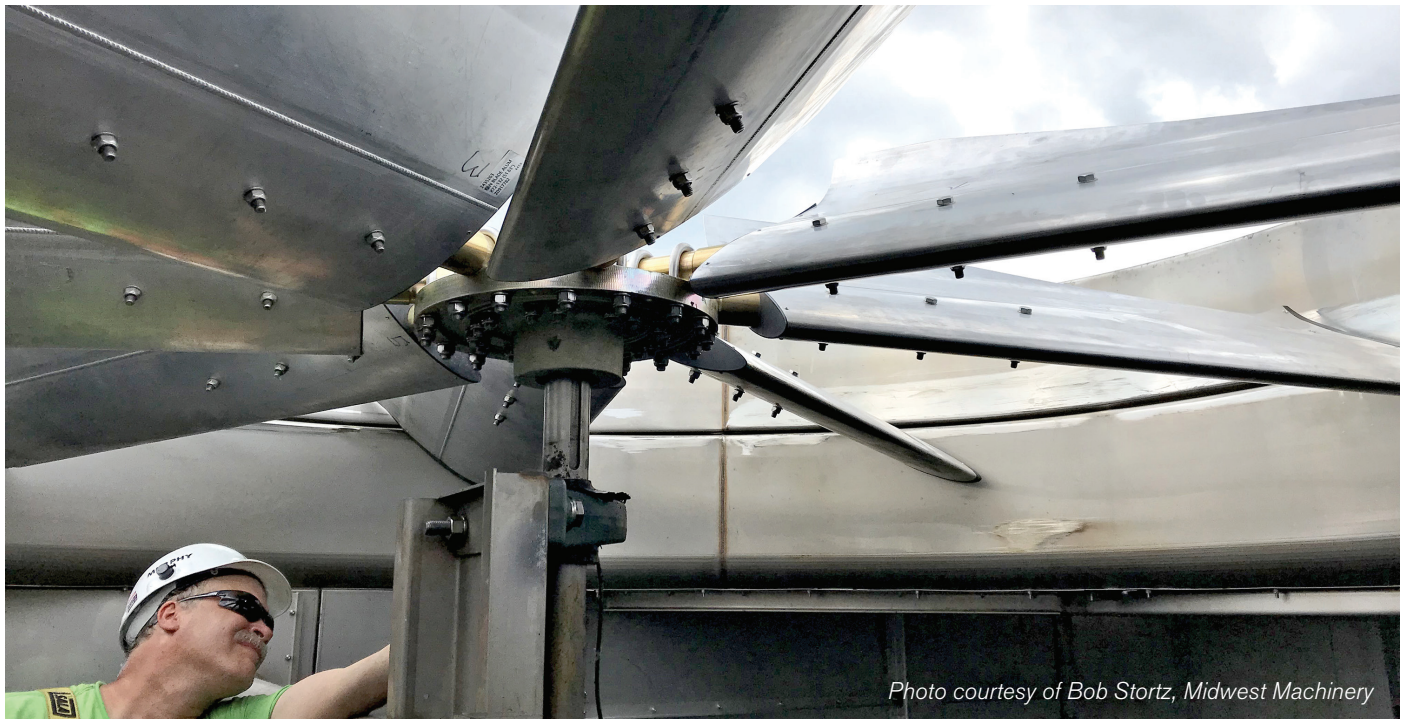
| Problem | The original fan was showing signs of failure, as cracks and fissures began to appear around the hub. |

| Solution | Before failure occurred, SPX Cooling Technologies expedited a Marley X7 fan to replace the original fan, preventing mechanical and structural damage. |
| Results | The customer's tower was returned to operating order. |
